# This Is the

By EMC(SS/SW) Greg Seplak,  
Naval Safety Center

# Mocking

# Truth

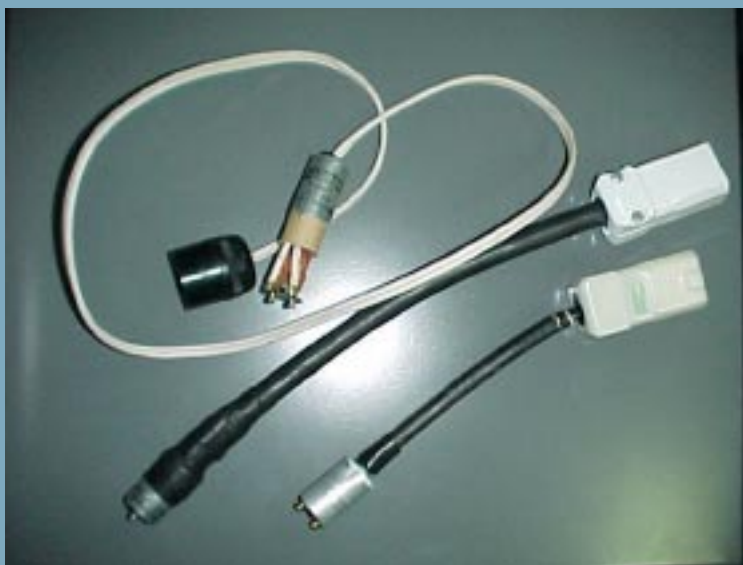
Shown are three examples of illegal, shipboard bunk-light extension cords. Note the three different wire gauges used, along with three different plugs. All three cords were made by soldering onto the connector terminals of fluorescent bunk-light starter capacitors.

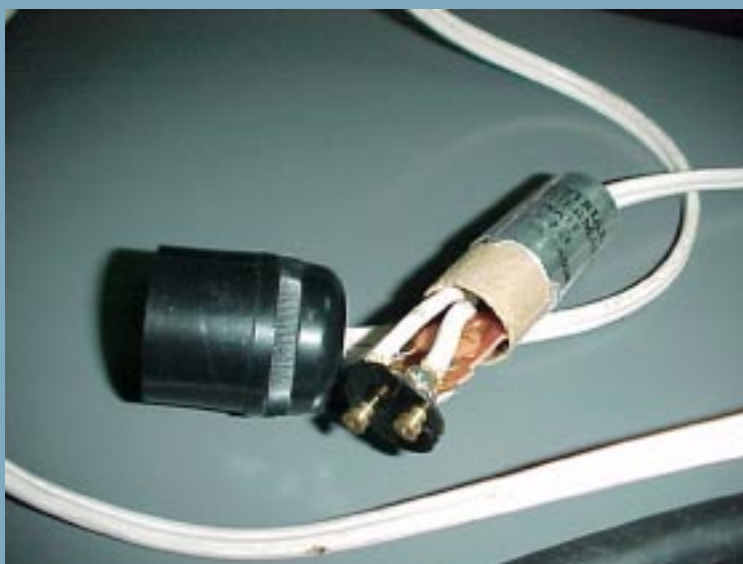
A closeup photo shows a jury-rigged, shipboard bunk-light starter capacitor where an illegal extension cord has been soldered onto the starter terminals. Aside from being illegal, these unauthorized extension cords are dangerous because they pose shock and fire hazards.
